**MARINE INVESTIGATION REPORT**  
**M04L0105**

**STRIKING OF WHARF**

**HIGH-SPEED PASSENGER CATAMARAN**  
*FAMILLE DUFOUR II*  
**PUBLIC WHARF, ÎLE AUX COUDRES, QUEBEC**  
**24 AUGUST 2004**

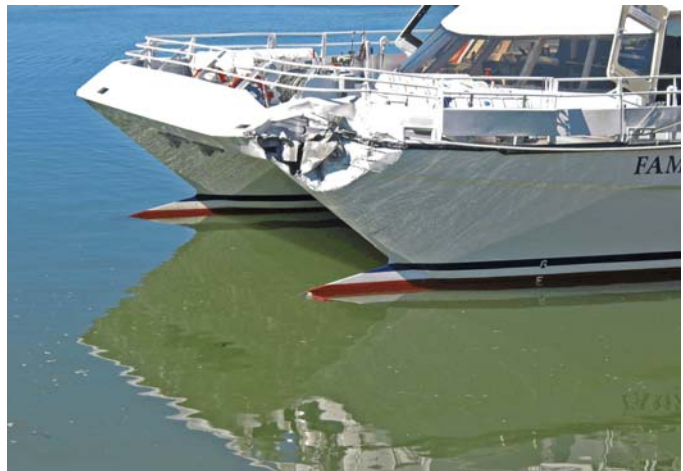
At approximately 0930, the vessel struck the southwest face of the public wharf at a speed of 8.7 knots and at an approach angle of about 37 degrees. The port corner of the bow and the port hull at the waterline sustained damage (see Photo 2).

**Photo 2.** Damage to the port bow

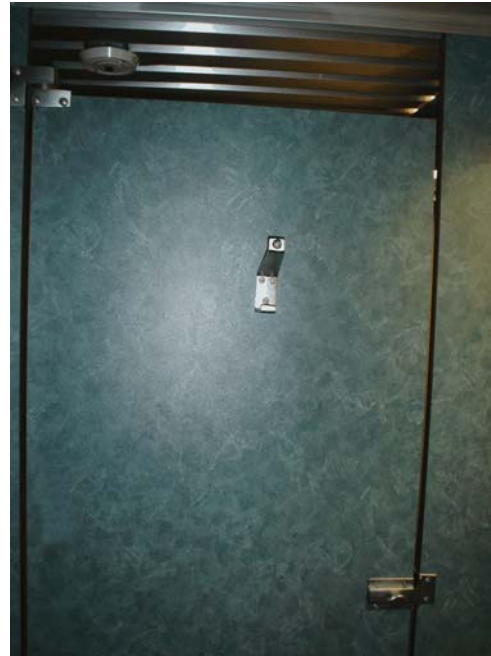
On board the *Famille Dufour II* there were a number of objects that had the potential to cause injury to passengers and crew in an accident because they were unsecured or inadequately secured. These included large metal garbage cans, electric fans, cash registers, a passenger service cart, several service tables, sound equipment, and various food and cleaning stores. Furnishings and finishings in passenger areas were also observed to be potentially injurious: these included, for example, protruding metal coat hooks (see Photo 3), flat-screen monitors, sharp edges on passenger tables (folded position), and non-tempered glass panels used in the gift-shop display case.

**Photo 3.** Aft-facing steel coat hook on the inside of the washroom door

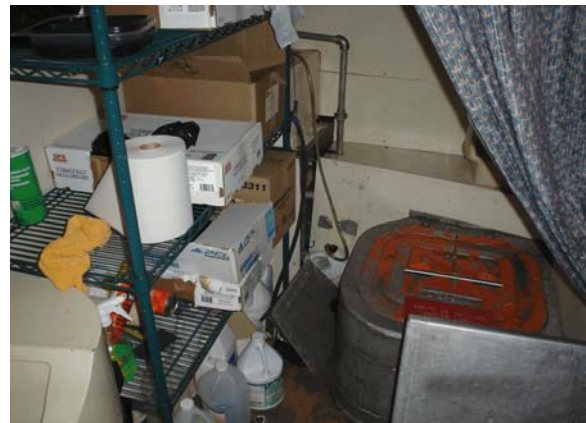
- unsecured stores stowed near the starboard engine room emergency escape hatch (see Photo 4);

**Photo 4.** Unsecured stores near the starboard engine room escape hatch

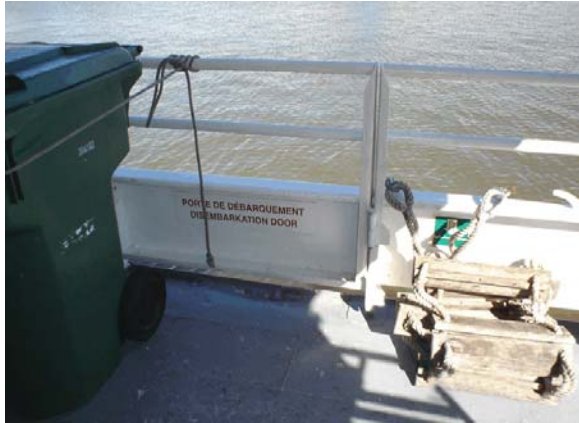
- trash bins lashed to embarkation gates (see Photo 5); and
- two Jacob's ladders for embarkation into the liferafts located at the forward end of the main deck, which were not rigged for immediate use but were stowed forward of the point of embarkation and secured to a deck pad eye by a shackle (see Photo 6).

**Photo 5.** Trash bin lashed to the aft starboard embarkation gate

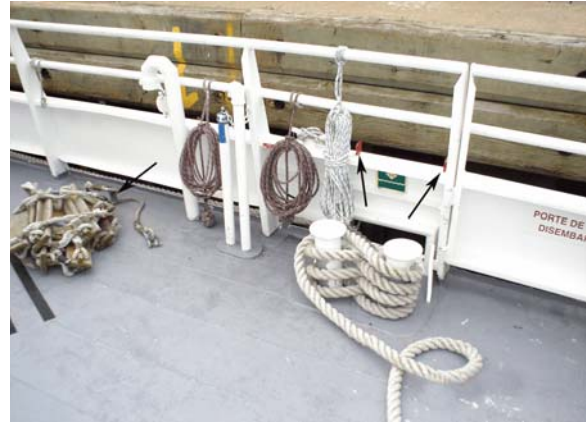
**Photo 6.** Port side Jacob's ladder secured to the main deck (left-hand arrow) and points for attachment when deployed (right-hand arrows)

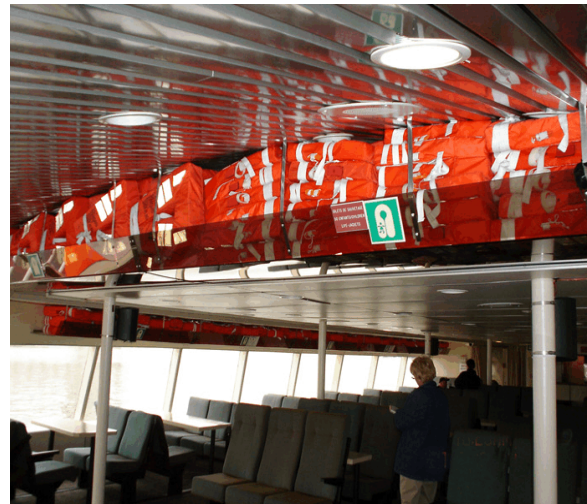
The lifejackets were tightly stacked within the rack and were difficult to retrieve because of the height of the front panel and the vertical metal strapping used to secure the rack in place. The height from the top of the front panel of the overhead rack to the deck was 2.18 m (86 inches). Although the row of seats under the overhead rack was in place at the time of the occurrence, its removal for seating reconfiguration happens from time to time on this vessel (see Photo 8).

**Photo 7.** Overhead rack containing adult (left-hand side) and children's (right-hand side) lifejackets

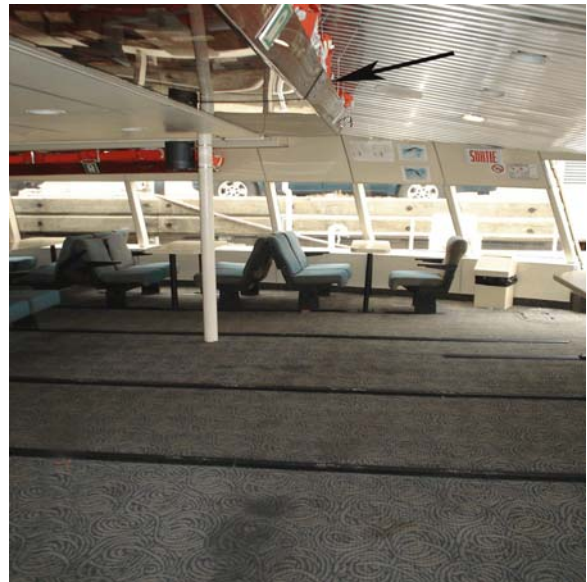
**Photo 8.** View of children's lifejackets (arrow) stowed in an overhead athwartships rack and rows of seats removed from the deck

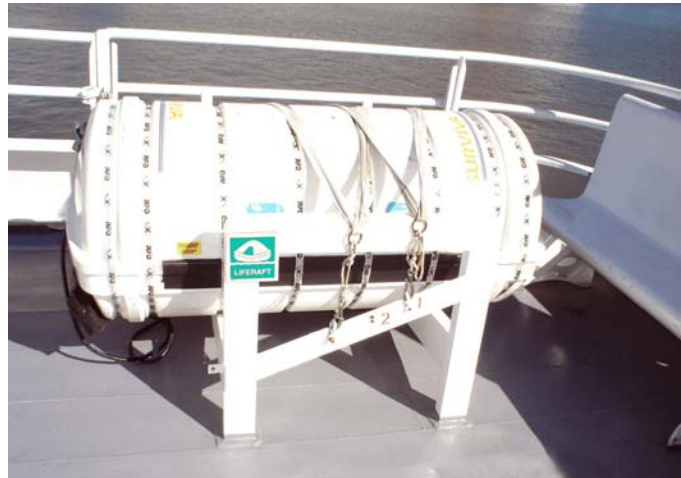
The vessel was equipped with ten 25-person and two 50-person RFD Surviva inflatable liferafts secured in their cradles by lashings fitted with senhouse slips (see Photo 9). Such a securing arrangement requires human intervention for the launching.

**Photo 9.** Liferaft secured by lashings fitted with senhouse slips

Although not a factor in this occurrence, the lashings that secured the vessel's 12 inflatable liferafts were fitted with senhouse slips that required manual operation to deploy the liferafts. The lashings did not incorporate a hydrostatic release unit or other system to allow the liferafts to float free in the event the vessel should sink.

In response, TC agreed that the liferafts of all passenger vessels should float free in the event of sinking. An amendment to the *Life Saving Equipment Regulations* will be sought to bring this into effect when the regulations are revised as part of Phase II of the *Canada Shipping Act* regulatory reform process. This work is expected to begin by the end of 2006. Meanwhile, TC issued Ship Safety Bulletin 03/2001, recommending that all vessels, irrespective of their size, stow their liferafts (other than davit-launched rafts) and inflatable rescue platforms so they float free in the event of sinking.
